CULTURAL LANDSCAPE RECOMMENDATIONS

PARK HEADQUARTERS AT MUNSON VALLEY
CRATER LAKE NATIONAL PARK

SUMMER 1991

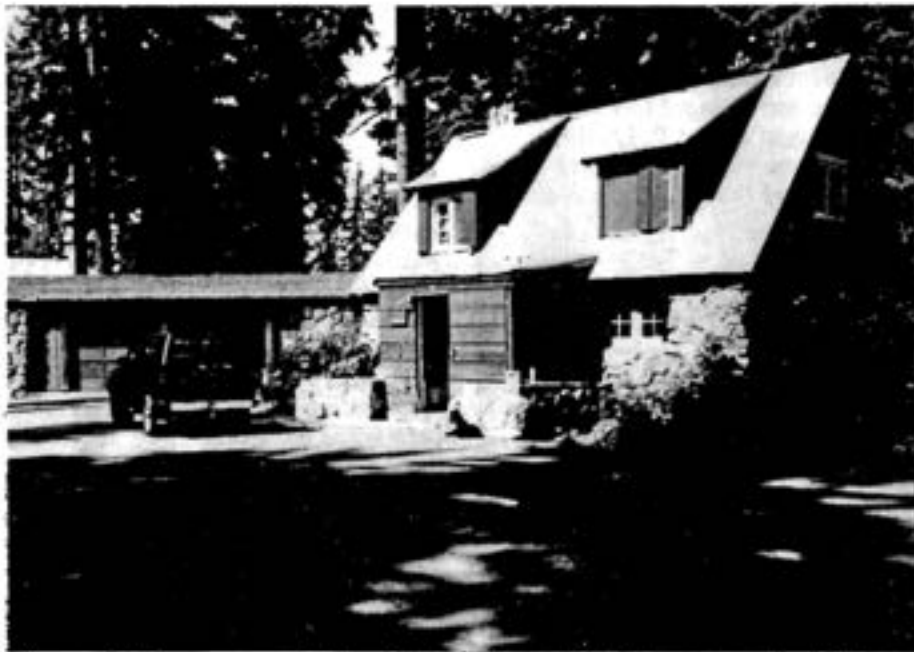
View south along spur road showing typical post WW II snow tunnel addition and widened road bed, 1990

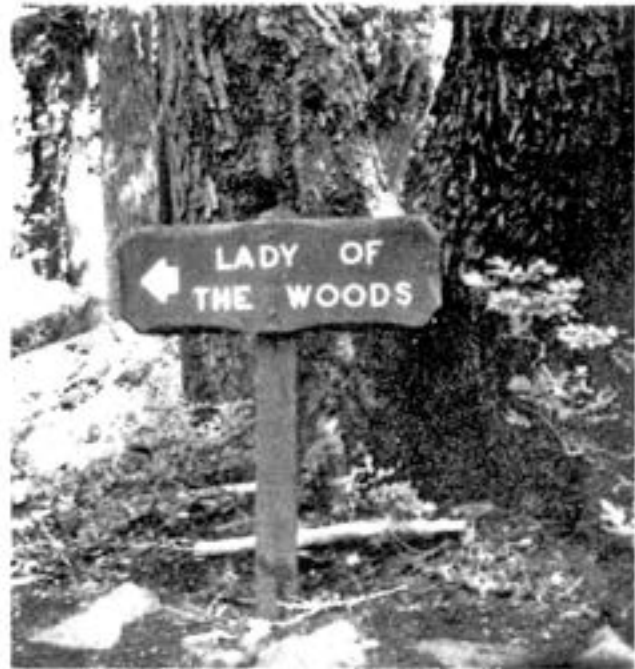
Mission 66 directional sign, routed wood painted brown with creme white lettering.

- a. Maintain adequate trail access to the sculpture.
- b. Replacement of the Mission 66 routed sign with a rustic wood sign should be considered.
- c. Routine cleaning of the sculpture should be included within the cyclic maintenance preservation program.

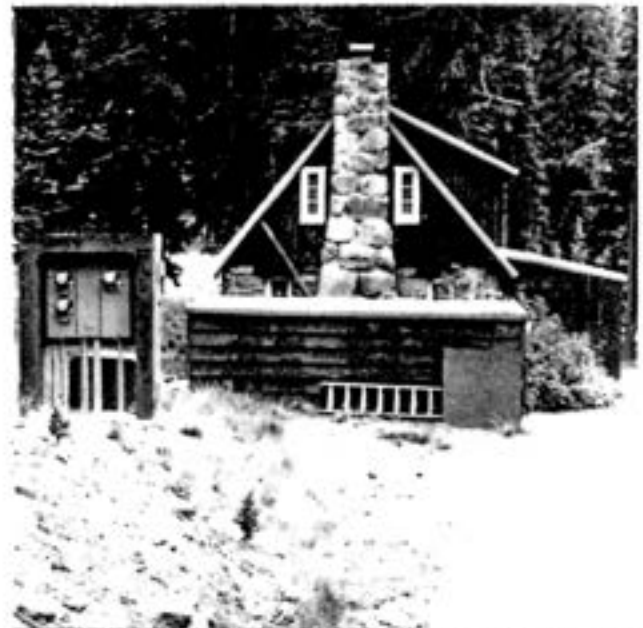
Utility box at the middle group of employee residences.

1. All historic structures on site within the historic district should be preserved and maintained under an approved cyclic maintenance preservation program. All significant structural resources should be incorporated into the Maintenance Management System, and the Inventory Condition Assessment Program (ICAP), including the Superintendent's Residence, Administration Building, and Ranger Dormitory.
2. Propane tanks sited in front of the employee residences are inappropriate and negatively impact the historic landscape. Burial, relocation or removal of the tanks is required.

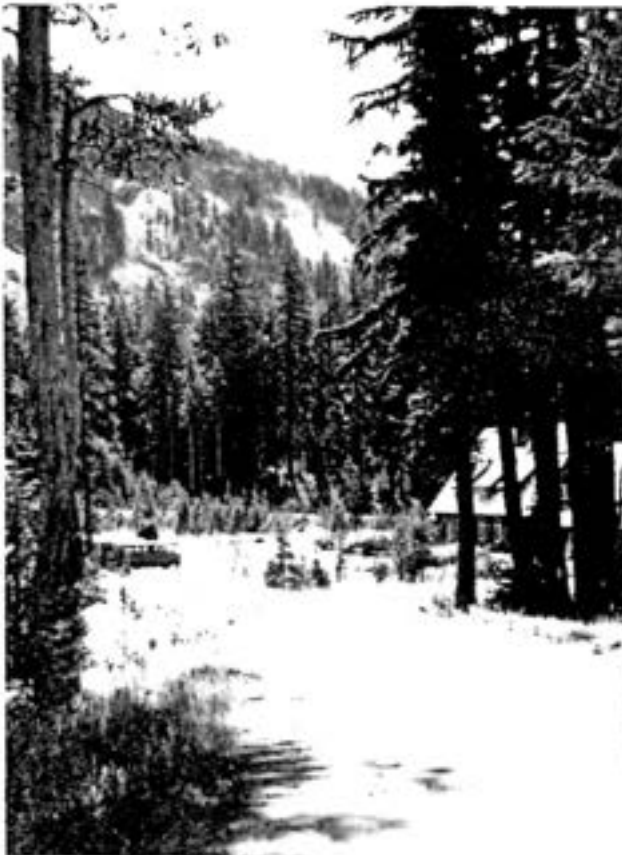
Parking lot north of the Administration building.

1. The administrative plaza should remain the main visitor arrival point. Visitor parking should remain concentrated in the plaza area. Employees should continue to use the parking lot north of the Administration Building.

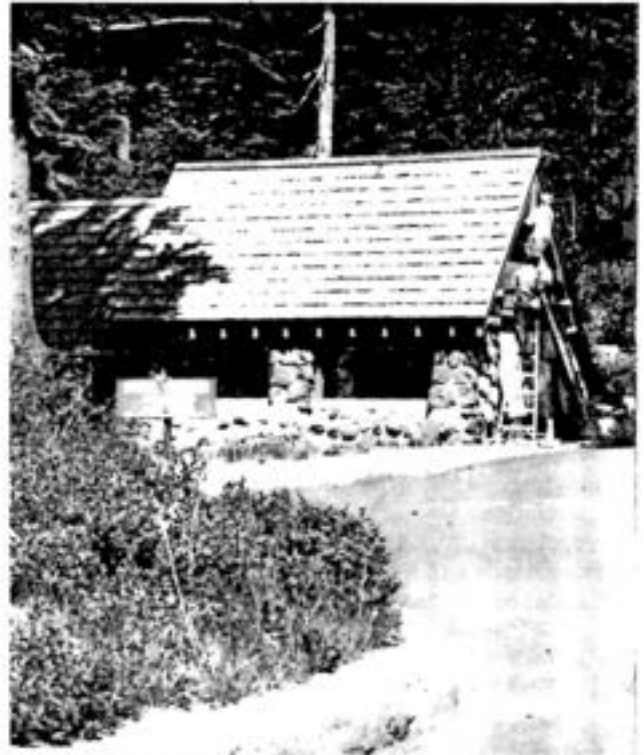
Remnant stone curbing around the ellipse and plaza area.

3. The condition of remnant stone curbing throughout the plaza area should be assessed to determine an

appropriate strategy for rehabilitation or replacement as noted under the maintenance and management recommendations.

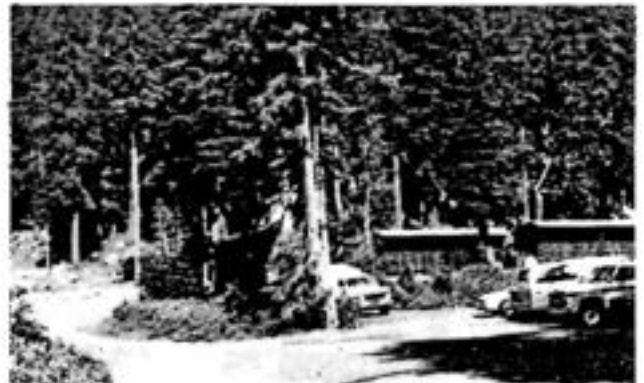
Planting "island" between the Messhall and Warehouse.

4. Reestablishment of stone curbing surrounding the planted "island" between the Mess Hall and Warehouse should be considered.

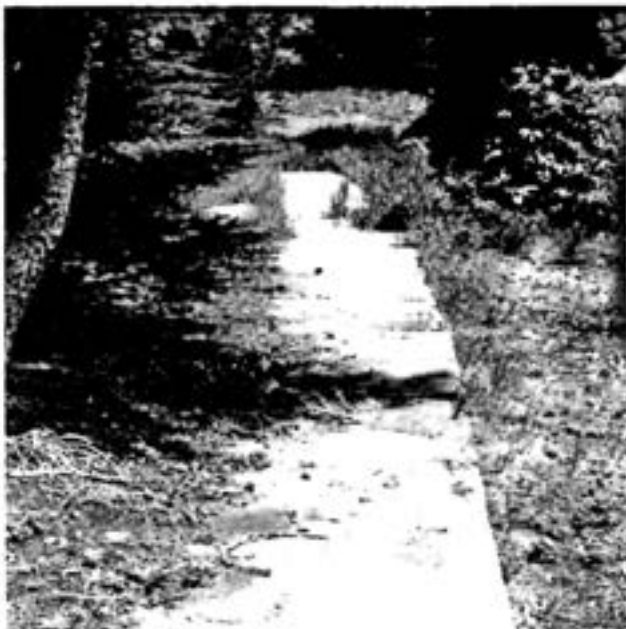
West flagstone walkway at the Superintendent's Residence.

1. Retain original circulation patterns.
2. The condition of all flagstone walkways, stone steps and the Munson Creek bridge should be assessed and an appropriate maintenance strategy for stabilization and preservation determined as noted under the maintenance and management recommendations.

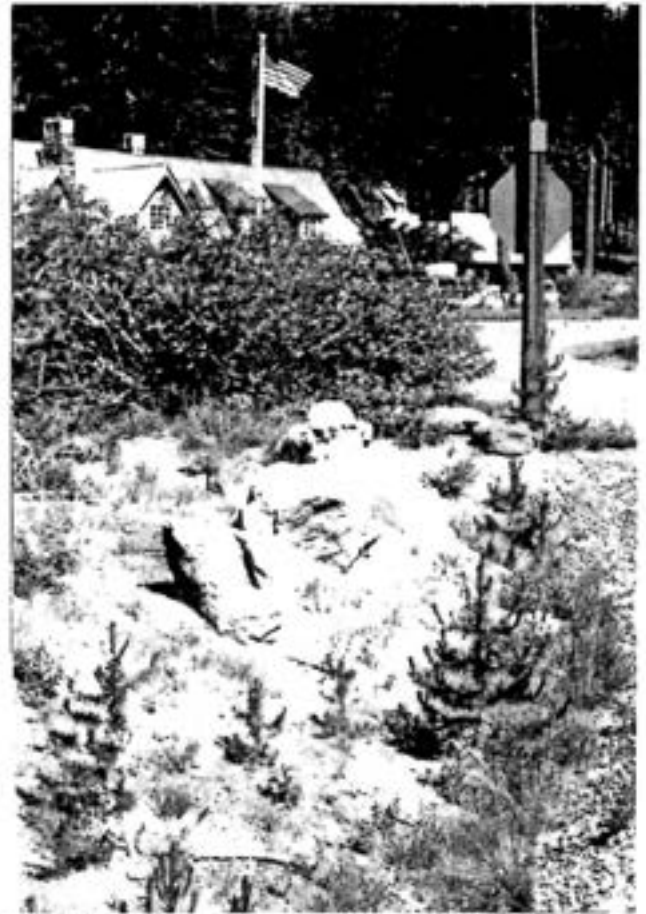
Extant boulders once used as a traffic control device for the old entrance to the plaza.

a. The condition of remnant stone features should be assessed in collaboration with the regional historical architect and historical landscape architect to determine an appropriate strategy for stabilization and maintenance, including cleaning and clearing of vegetation to enhance visibility as noted under the maintenance and management recommendations.

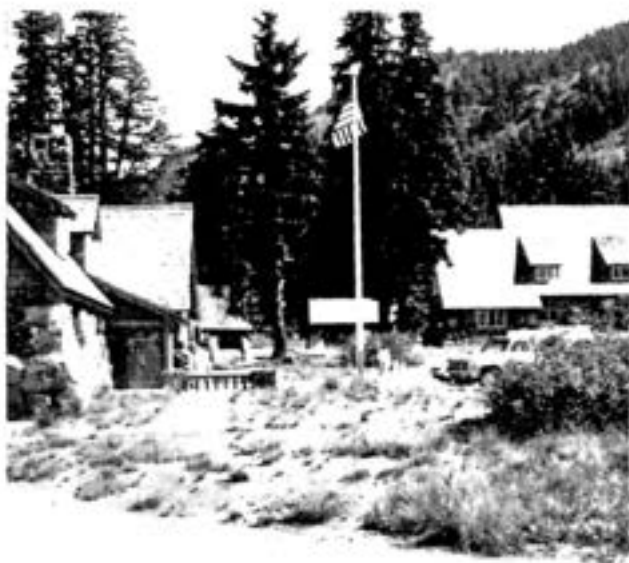
Remnant plant materials, 1990.

develop and implement a restoration planting plan. The plan should employ naturalistic design principles described in 1929-38 park documents, including tree placement to create shadows, and the general placement of native plant materials in natural groupings and associations. Prepare a preservation maintenance plan with recommendations for stabilization of remnant plant materials, routine and winter maintenance considerations.
