CULTURAL LANDSCAPE RECOMMENDATIONS

PARK HEADQUARTERS AT MUNSON VALLEY
CRATER LAKE NATIONAL PARK

SUMMER 1991

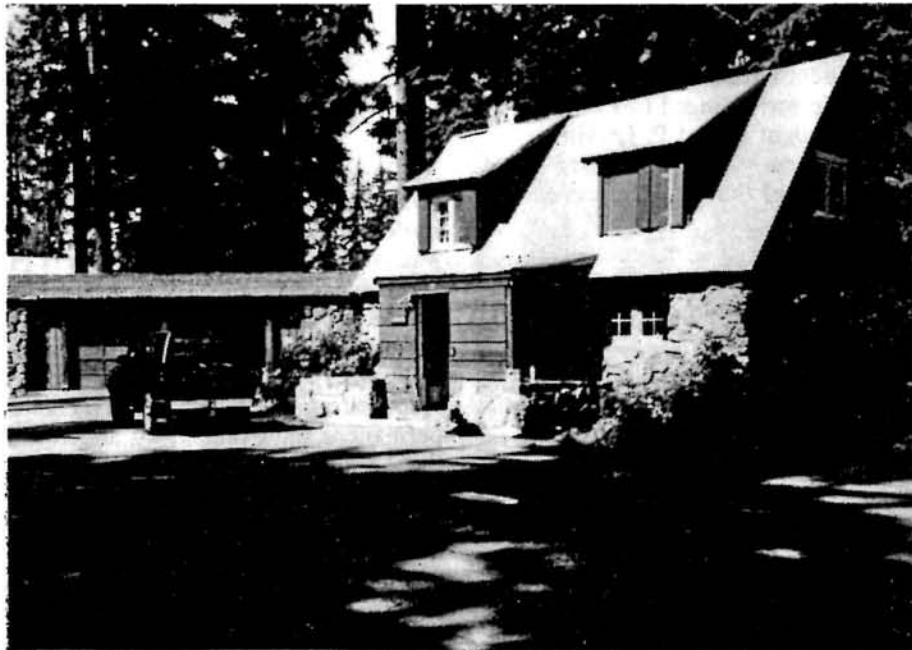
View south along spur road showing typical post WW II snow tunnel addition and widened road bed, 1990

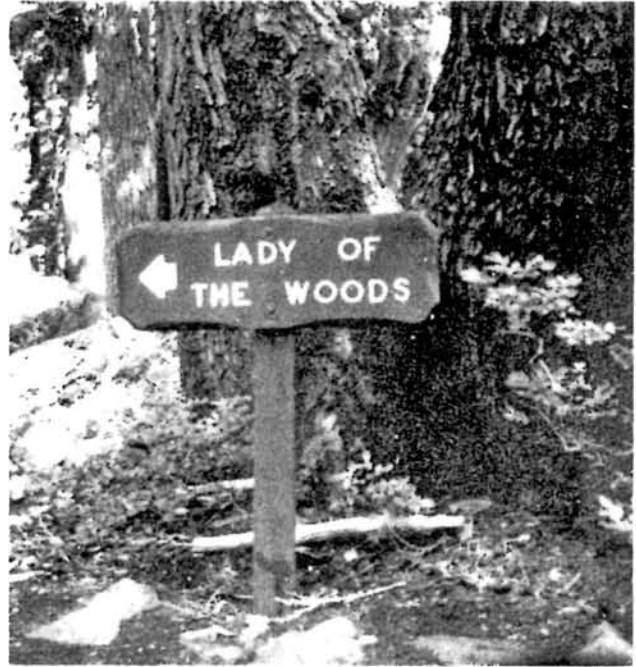
Mission 66 directional sign, routed wood painted brown with creme white lettering.

a. An overall sign for the site plan should be developed based on a hierarchy of style and type of information required. The plan should be consistent with the park-wide plan and should address the possibility of reestablishing Rustic style signs at the administrative complex.

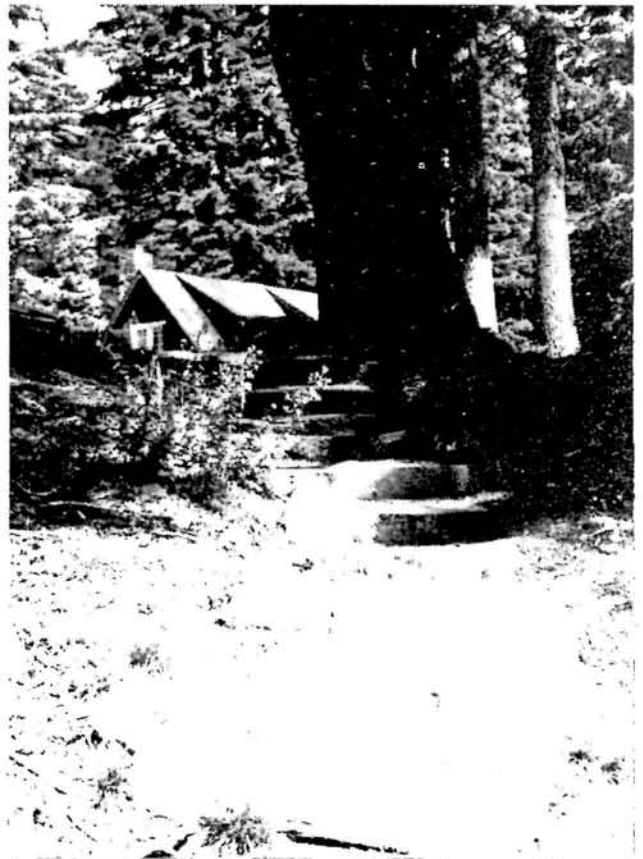
Stone steps to the lower group of employee residences.

1. Retain original circulation patterns.
2. The condition of all flagstone walkways, stone steps and the Munson Creek bridge should be assessed and an appropriate maintenance strategy for stabilization and preservation determined as noted under the maintenance and management recommendations..

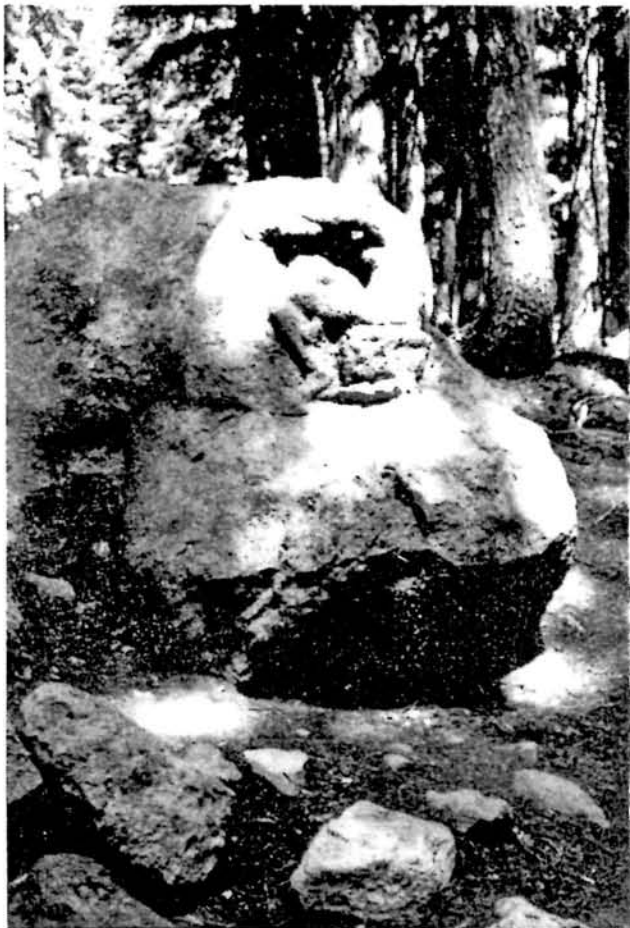
Carved by Earl Russell Bush in 1917, the sculpture stands approximately three feet high and is located 400 feet west of the Ranger Dormitory. A rustic wood sign identifies the site which can be reached by trail from the plaza area.

Lady of the Woods.

- a. Maintain adequate trail access to the sculpture.
- b. Replacement of the Mission 66 routed sign with a rustic wood sign should be considered.
- c. Routine cleaning of the sculpture should be included within the cyclic maintenance preservation program.

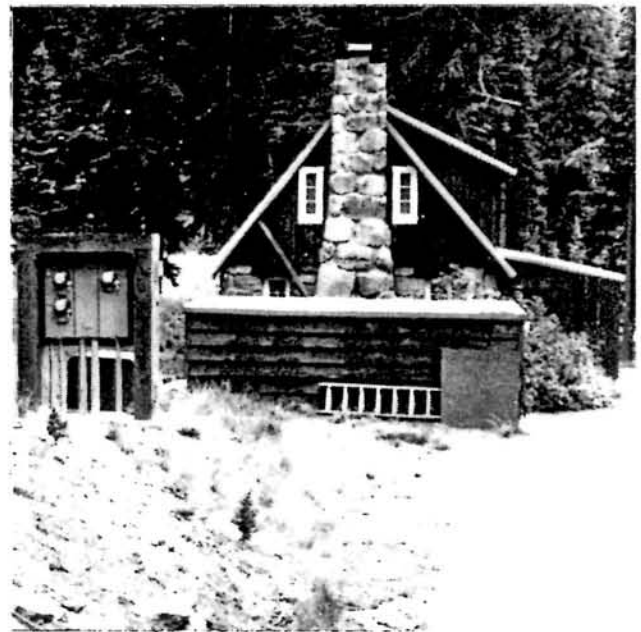
Utility box at the middle group of employee residences.

2. All modern intrusions such as above ground utilities, maintenance structures, and service areas that conflict with the historic scene should be screened or ideally removed. Future intrusions on the site should be avoided, but if necessary, should be appropriate in scale, color, and mass and adequately screened. (See Building and Structures Recommendation #2.)

1. All historic structures on site within the historic district should be preserved and maintained under an approved cyclic maintenance preservation program. All significant structural resources should be incorporated into the Maintenance Management System, and the Inventory Condition Assessment Program (ICAP), including the Superintendent's Residence, Administration Building, and Ranger Dormitory.
2. Propane tanks sited in front of the employee residences are inappropriate and negatively impact the historic landscape. Burial, relocation or removal of the tanks is required.

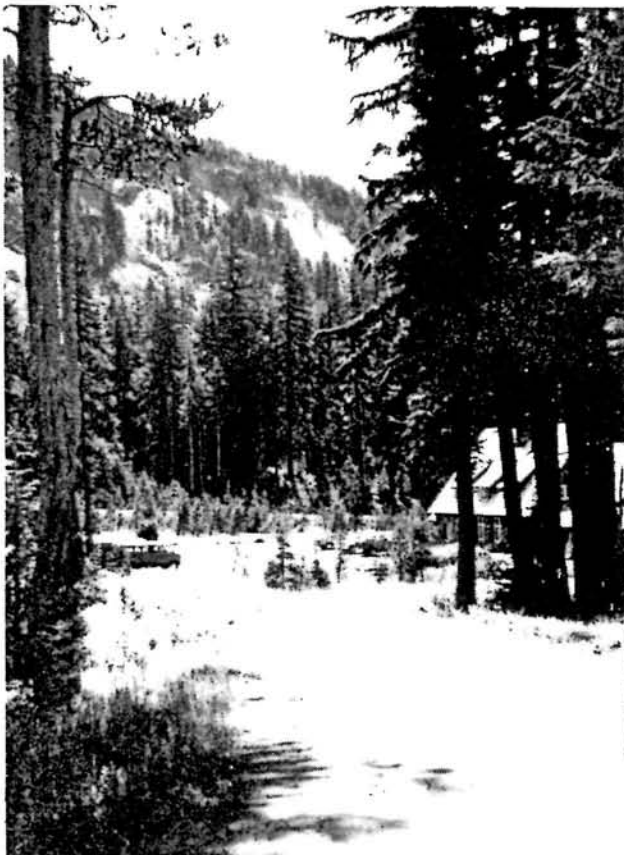
Parking lot north of the Administration building.

1. The administrative plaza should remain the main visitor arrival point. Visitor parking should remain concentrated in the plaza area. Employees should continue to use the parking lot north of the Administration Building.

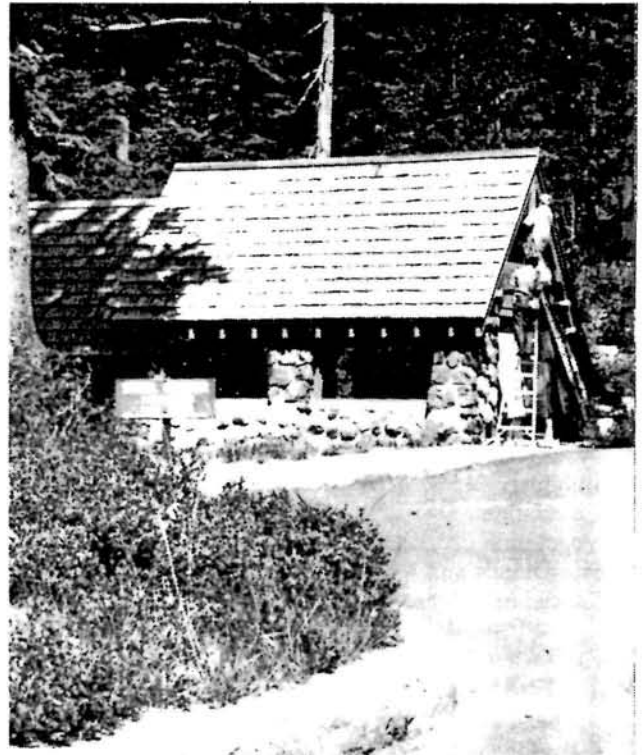
Remnant stone curbing around the ellipse and plaza area.

3. The condition of remnant stone curbing throughout the plaza area should be assessed to determine an

appropriate strategy for rehabilitation or replacement as noted under the maintenance and management recommendations.

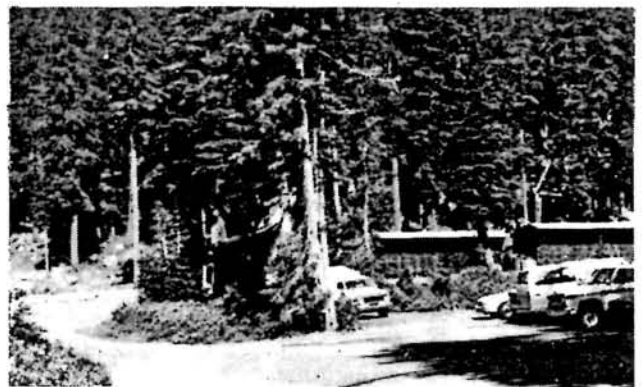
Planting "island" between the Messhall and Warehouse.

4. Reestablishment of stone curbing surrounding the planted "island" between the Mess Hall and Warehouse should be considered.

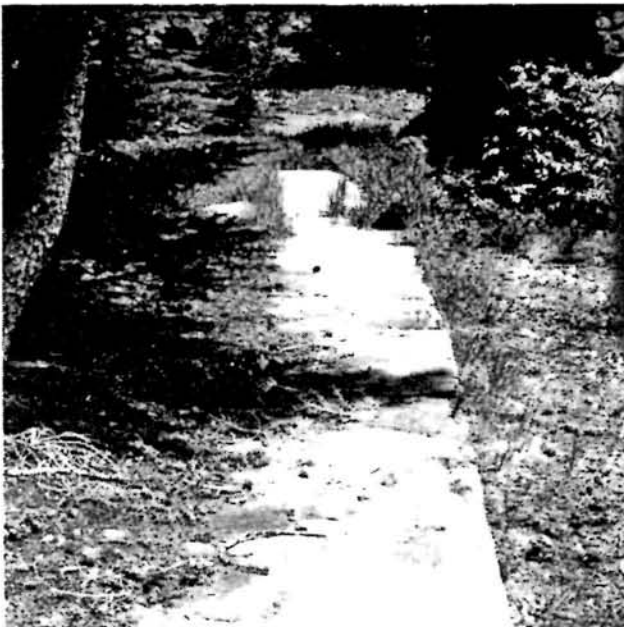
West flagstone walkway at the Superintendent's Residence.

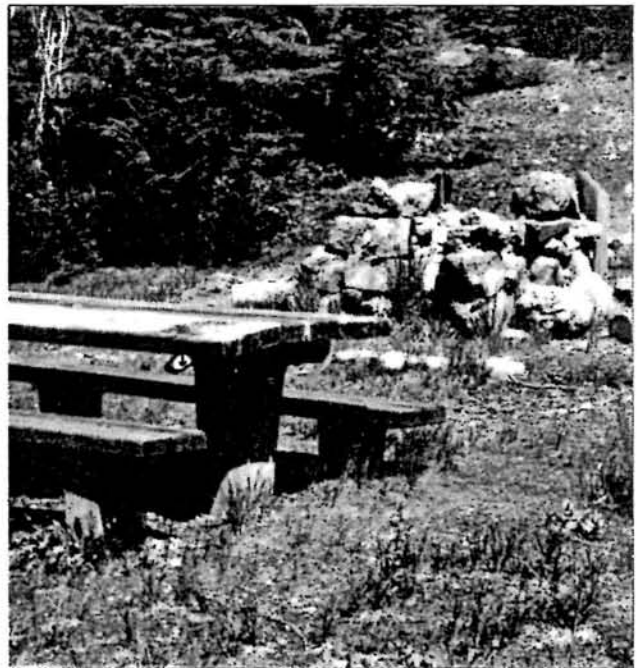
Picnic table and stone fireplace at the Superintendent's Residence.

1. Site furnishings (light fixtures, garbage cans, bike racks, signs and interpretive displays) should be visually compatible with the identified elements of the rustic style including scale, texture, and the general site character of Munson Valley. Furnishings should meet all applicable codes and regulations. Complementary design rather than replication is the preferred treatment for rehabilitation and/or replacement of site features.

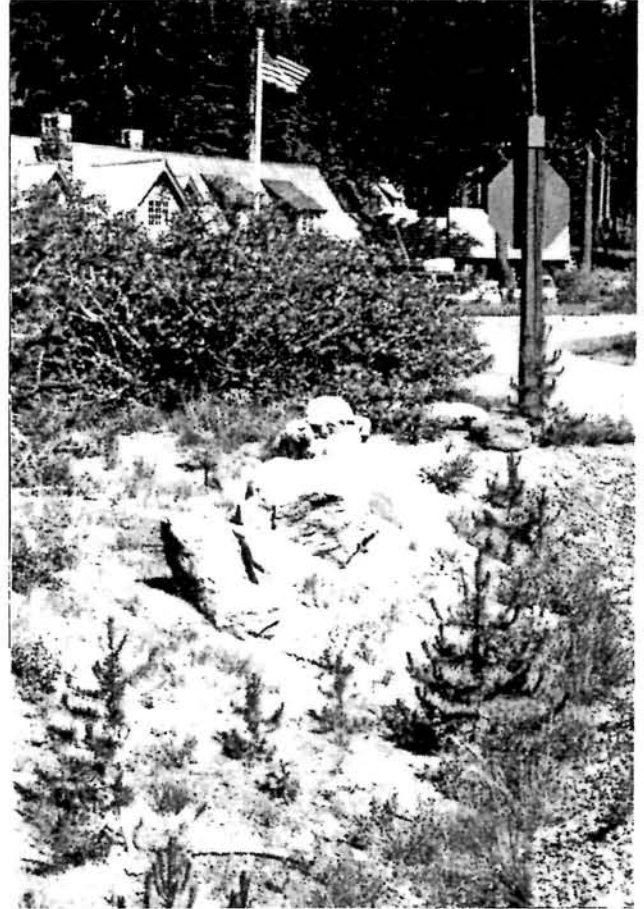
Extant boulders once used as a traffic control device for the old entrance to the plaza.

a. The condition of remnant stone features should be assessed in collaboration with the regional historical architect and historical landscape architect to determine an appropriate strategy for stabilization and maintenance, including cleaning and clearing of vegetation to enhance visibility as noted under the maintenance and management recommendations.

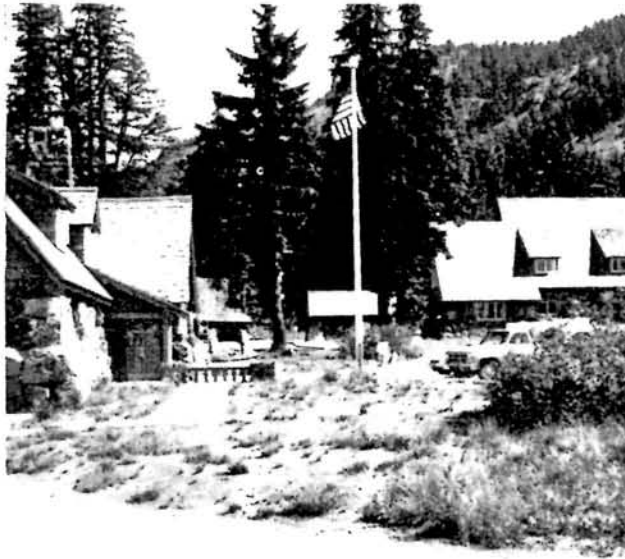
Remnant plant materials, 1990.

develop and implement a restoration planting plan. The plan should employ naturalistic design principles described in 1929-38 park documents, including tree placement to create shadows, and the general placement of native plant materials in natural groupings and associations. Prepare a preservation maintenance plan with recommendations for stabilization of remnant plant materials, routine and winter maintenance considerations.
